RED WALL

PROPERTY INSPECTION REPORT

WAYNE GARDNER - OREGON CERTIFIED HOME INSPECTOR

123 Main St - Portland, OR . 97000

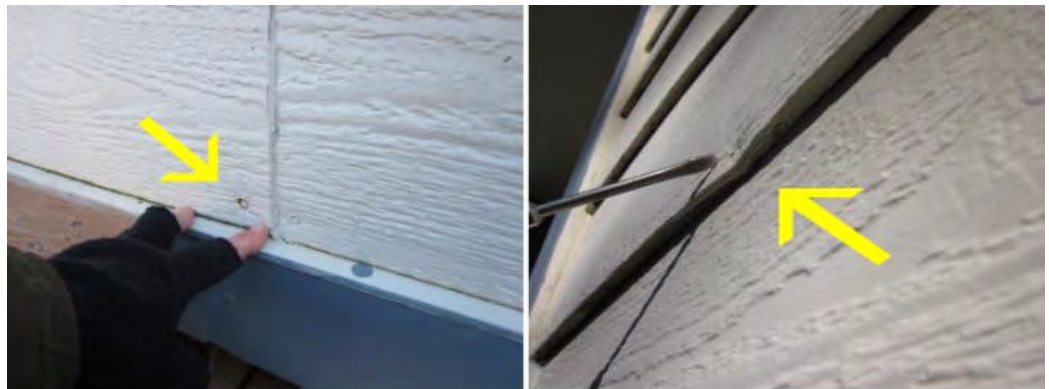
SIDING:

MAJOR CONCERN - Due to the potential cost for residing the home, this is a Major Concern. See below. The cladding on the home is a composite type and it is consistent with the composite siding manufactured by Louisiana Pacific (LP) in the early/mid 1990's. This type of siding is known to be prone to moisture absorption issues and may have been part of a class action law suit. To my knowledge, the law suit has ended and there is no longer funds available from the manufacturer. You should investigate this for yourself as my information may be incorrect. In my experience, most of this type of siding has been replaced by this time.

CONDITION: I was surprised to find the siding in relatively serviceable condition. Make no mistake, there are several areas where moisture absorption is occurring and the siding is in a state of break down but is generally performing as siding should. These areas are most prevalent on the south and west sides of the

home. I observed the worst areas at upper level butt joints. See the photos for the areas I am describing.

RECOMMENDATION: You should plan to have the siding replaced. You should contact a qualified contractor to review the siding and provide you with pricing for replacement. Until replacement occurs, keep the siding and joints well caulked and painted to slow/minimize the damage as much as possible.

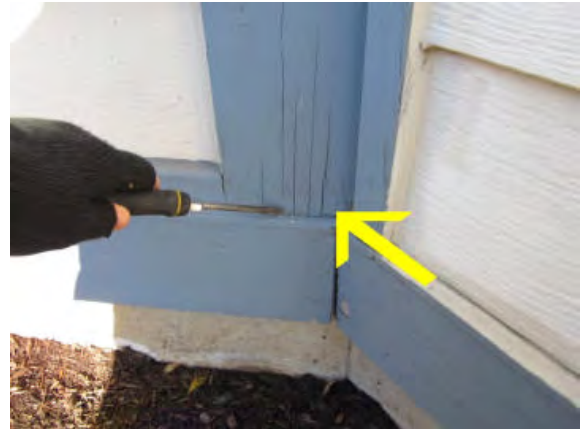
TRIM:

I noted peeling paint at trim areas. You need to ensure all wood surfaces are properly painted. When wood is left bare, rot and decay begins.

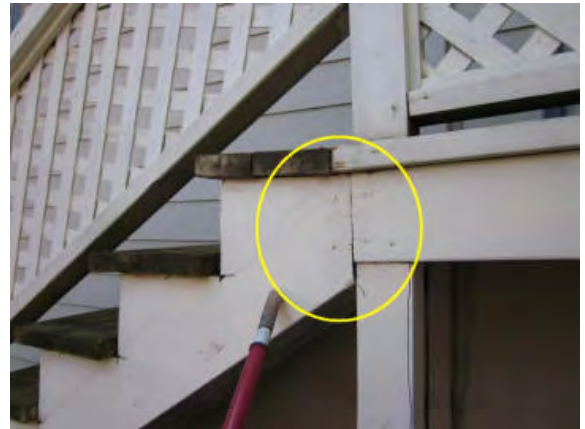
STOOPS & STEPS:

CAUTION - The rear entry steps have several concerns. The steps are not well attached to the platform (weak connection). The platform is not well attached to the house and is not flashed to prevent damage to the siding or interior walls. Have a qualified contractor review the stairway and repair it as needed.

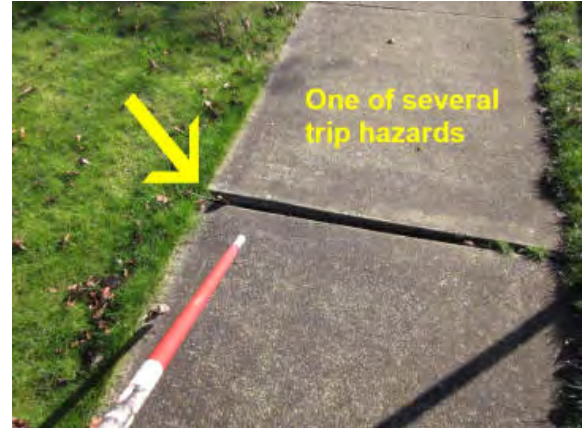
PUBLIC WALKWAYS:

MAJOR CONCERN - The sidewalks are damaged/settled and are in need of repair. There are several lifted sections which now present trip hazards to pedestrians. It appears trees are the culprit and tree removal may be part of a long term solution. This increases the cost of the repair as an arborist should be consulted also. You should know that sidewalk repairs are generally the responsibility of the homeowner and repairs should be made when a sidewalk presents a hazard to pedestrians.

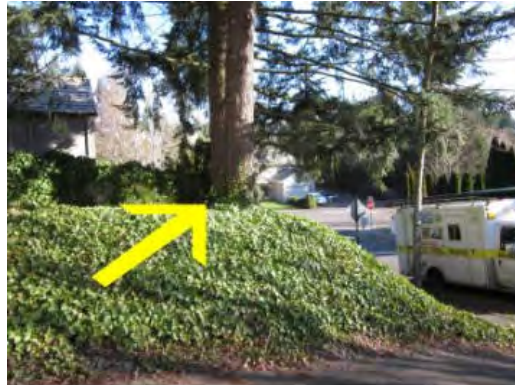
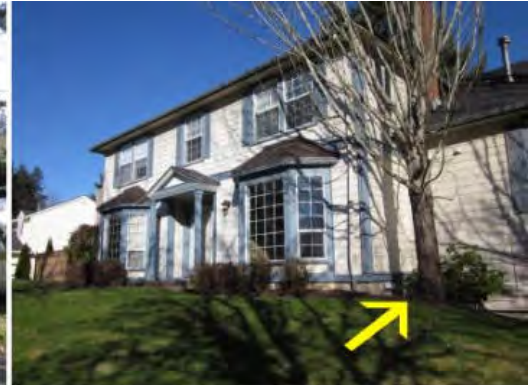
LARGE TREES:

There are 2 issues to consider in the future:

- There are 2 very large pine trees at the NE end of the driveway which are atop a slope which shows evidence of movement to the down hill side. Although the trees were straight up and down today, there is a chance they could also begin to move down the slope in the future.
- There is a large tree very near the home at the front. Keep them well trimmed to prevent damage to the roof and siding. These trees also assist animals in accessing your roof. If found to be a problem, consult with an arborist for recommendations.

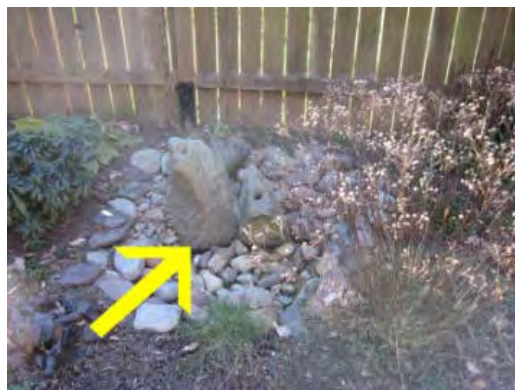
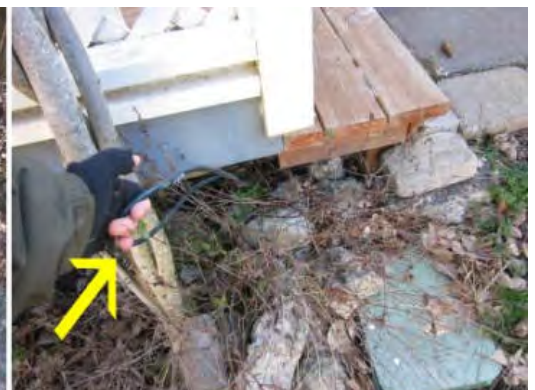
HAZARDS:

There is a water feature at the south fence area. I don't know if it operates or even if it has electrical power to it. There is an electrical cord under the deck but I don't know where it goes. If in fact the fountain does use electricity, have your electrician review it and install proper wiring as needed.

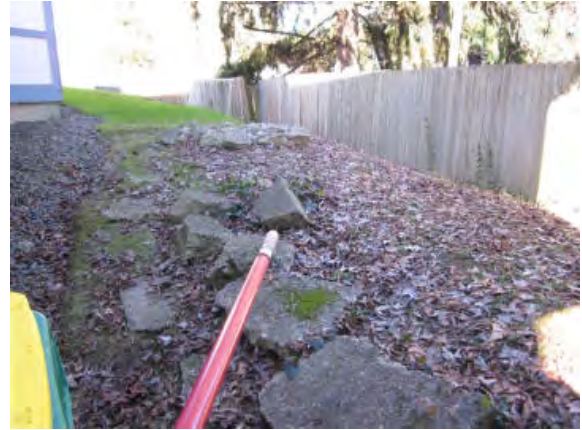
CAUTION - There are large pieces of broken concrete in the back yard. There are several sharp edges. Consider having this material removed.

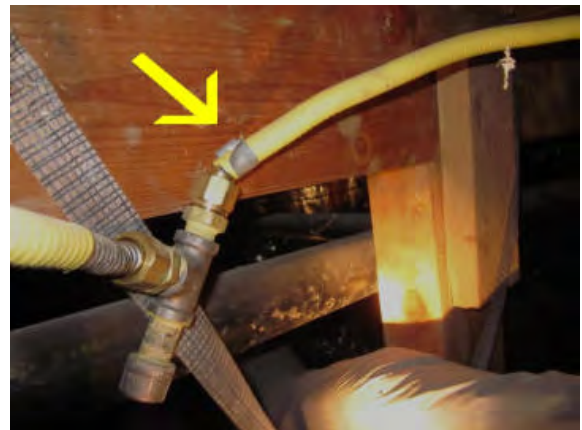
GAS PIPING:

There is a loose gas line clip in the crawlspace, under the range. Secure the clip properly.

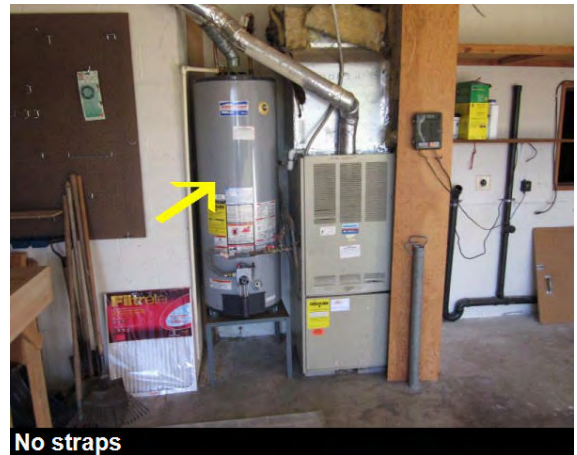
CAUTION - The water heater is not strapped in place to protect it from moving during a seismic event. Have the water heater secured in place using 2 metal straps at the upper and lower third sections of the tank. If there is a single strap present at this time, a second strap should be added.

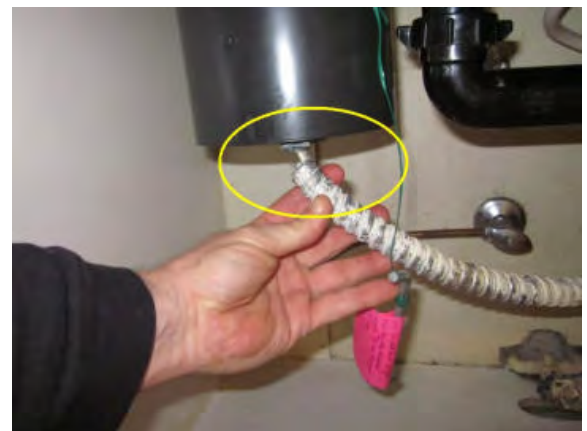
DISPOSAL WIRING:

The wiring at the base of the disposal is a potential hazard. It is not properly clamped/secured at the base of the unit. The wiring could be easily pulled from the disposal unit and become hazardous. Have the wiring repaired.

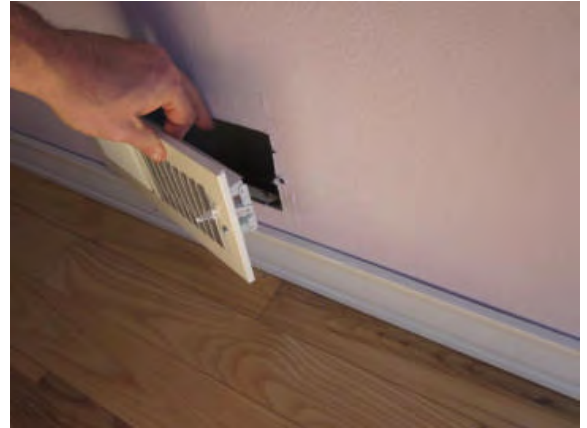
DAMAGED DUCTWORK:

Loose register covers observed in upper shared bath and in SW bedroom. There may be others. Secure/repair all covers.

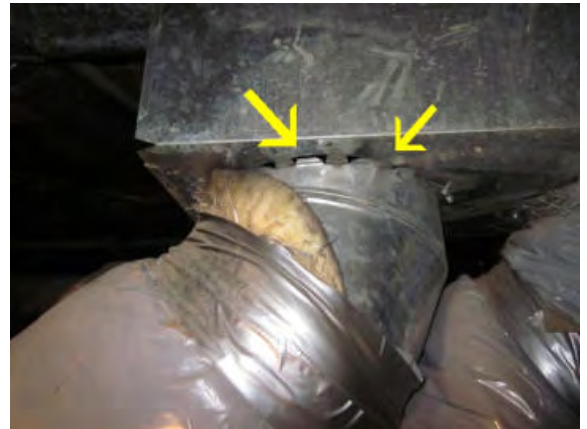
DISCONNECTED DUCTWORK:

There is a gap where the ductwork meets the branch line in the crawlspace. Have the connections repaired to prevent air leakage.

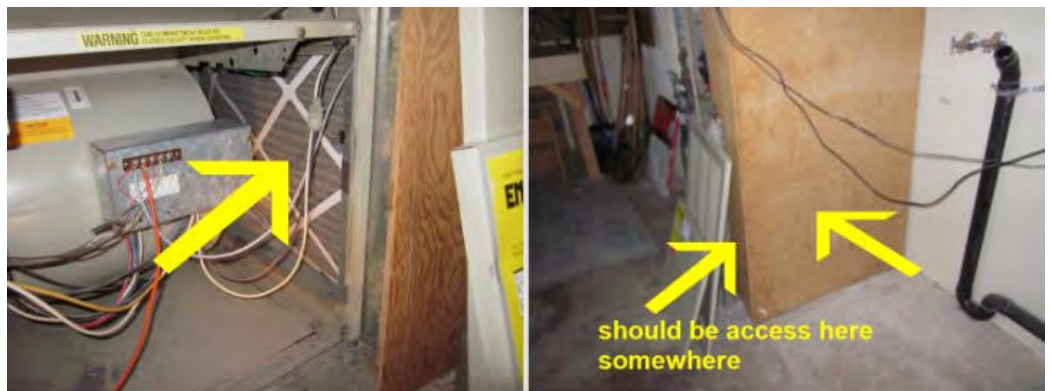
FILTER:

The filter is not properly accessible. The cover/opening appears to have been covered by the wood face at the front of the return line (next to the furnace). I did not observe any easy way to properly remove/replace the filter. Include in recommended review.

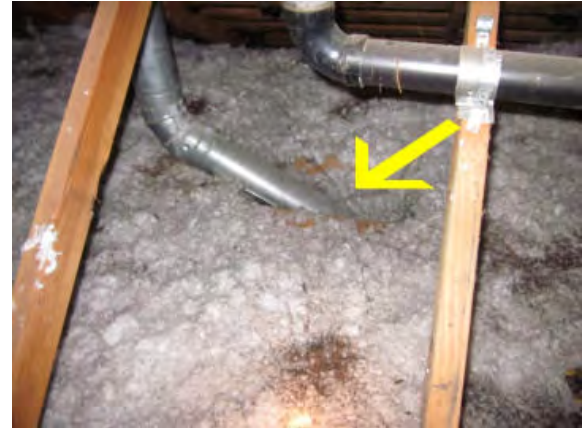
VENTING:

The metal vent pipe is in contact with insulation as it goes into or through the attic. Insulation is considered a flammable material in this case and as such, there should be no contact with the metal vent pipe. Clear away the insulation in these areas and install protective metal barriers to help keep the insulation away.

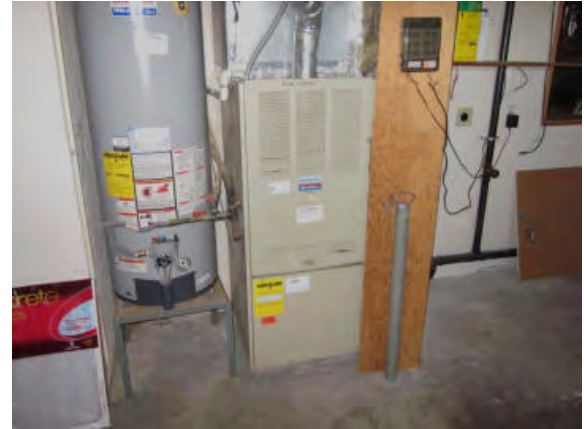
GENERAL CONDITION:

MAJOR CONCERN - This is an older furnace. It has reached its typical life expectancy and is still in operation. The main concern is the SAFE operation of the unit as heat exchangers typically fail by now, as noted above. Before you buy this furnace, have it fully evaluated, cleaned and tuned (if found safe to operate) by a qualified HVAC contractor. You should also ask the HVAC contractor for information regarding the remaining life of the unit and cost for replacement. Plan your budget accordingly. You should be prepared to replace the unit at any time. It should also be serviced prior to every heating season at this point.

Also - Front cover is bent and does not fit properly.

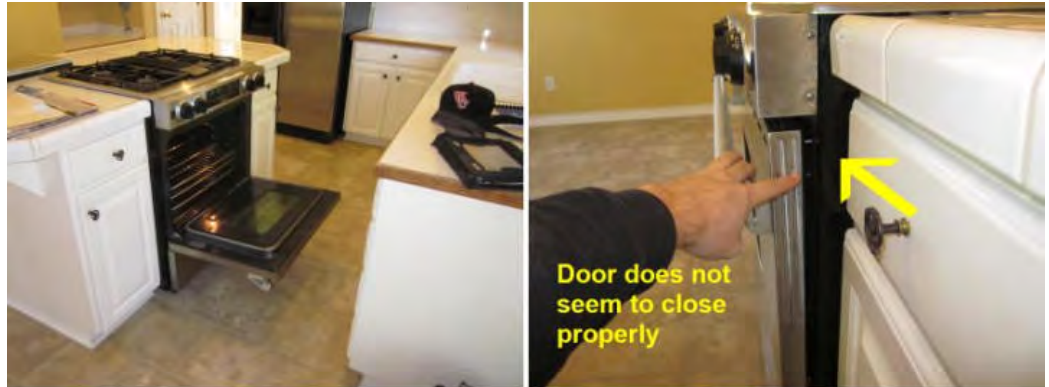
RANGE/OVEN:

CAUTION -

- The range does not fit in the opening/area properly. There are gaps at the countertop and when the door is open, there is improper access to the oven. This is a potential hazard. Consider reconfiguring the area for improved utility.
- The door appears to be sprung and does not appear to completely close. Contact the manufacturer for recommendation.

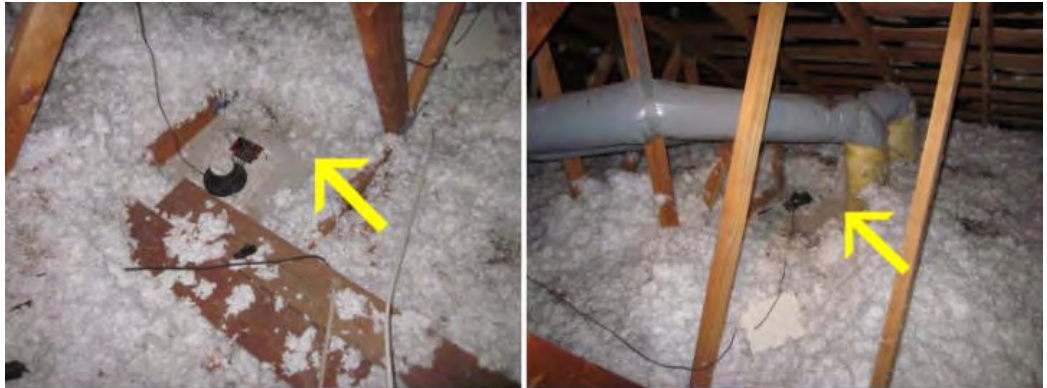
ATTIC INSULATION:

- The previous owner installed speakers in the master bedroom ceiling. In the attic above this area, the insulation was removed and never replaced. You need to install insulation in this area. Protect the speakers for fire safety.
- A previous owner has traversed the upper attic area to run wiring, resulting in compacted insulation in these areas as well as some missing insulation. You should add more insulation in these worn/missing areas to restore the R-value.
